Troubleshooting an Olive O4HD and Replacing the Hard Disk

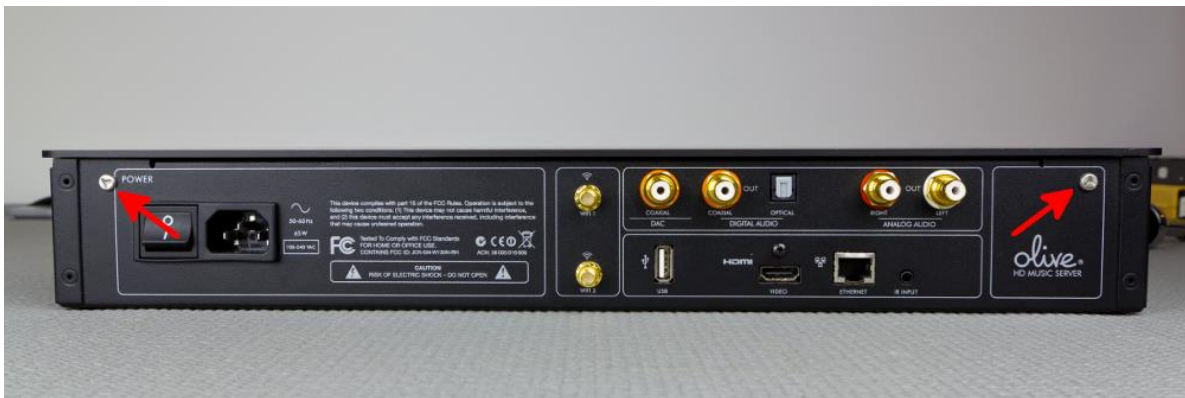
In order to get inside the unit I had to remove two tri-wing screws on the back. There are two flat flex cables connecting the motherboard to the front display. These cables do not have a lot of slack so the top should not be slid forward too much while removing it.

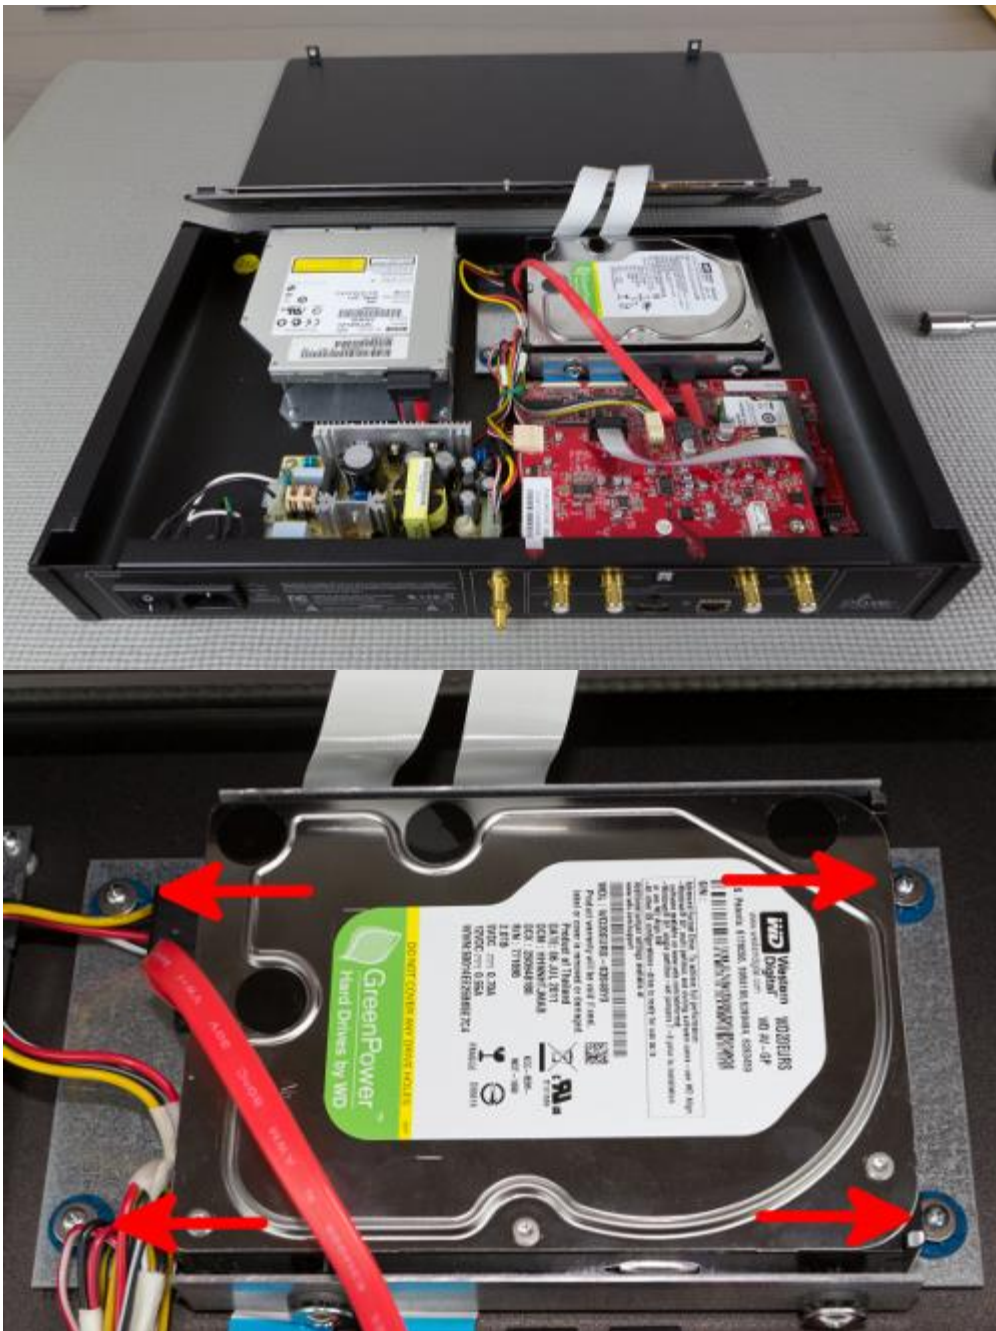
The hard drive is mounted onto a carriage that rests on four vibration dampers. I removed the four screws holding the carriage down, unplugged the drive's SATA power and data connections, and lifted it out of the player. As I imaged the drive I got my first hint at what might be causing the player to lock up - the hard disk would occasionally freeze while I was reading data from it. The issue was sporadic enough to allow me to create a fully image without issue.

I selected a [2TB Western Digital Caviar Green](#) drive as a replacement. The drive has nearly identical characteristics while using fewer watts. This is an important consideration for a drive

After cloning the hard drive I placed it back into the player and put everything back together. The player started up successfully and has been working well since.
